# **Nesbitt Dam**

Scranton, Pennsylvania

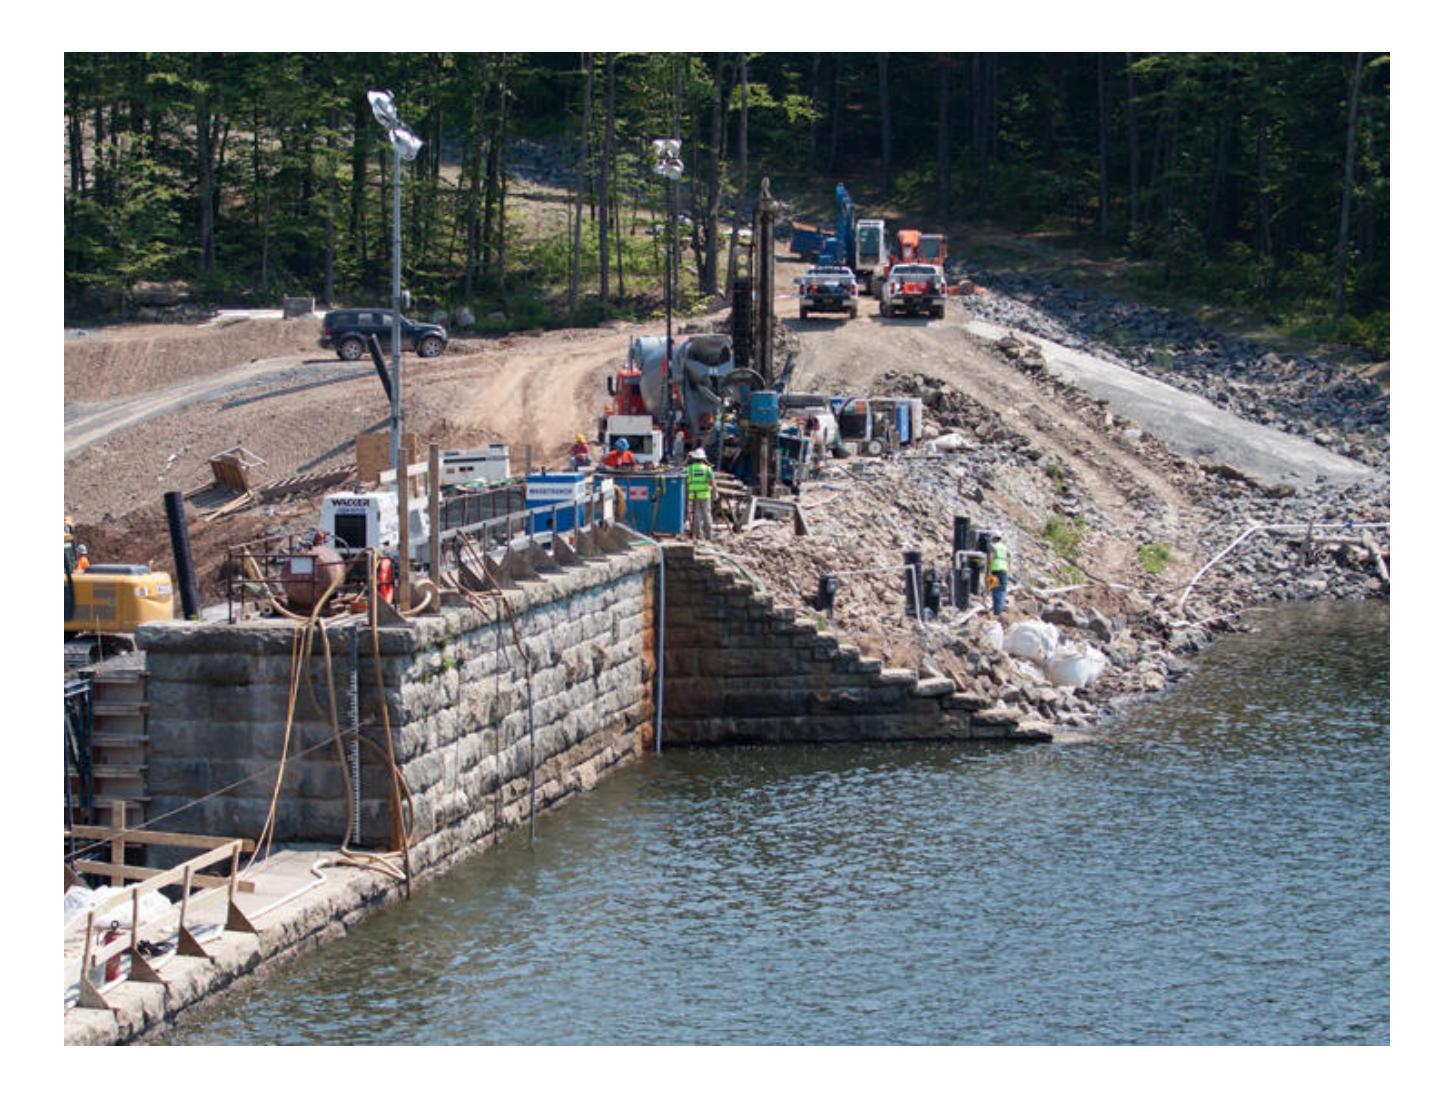
Nesbitt Dam, constructed in 1901, is a composite earth embankment and stone masonry structure, 101 ft high and 538 ft in length. The dam is partially founded on a rock outcrop that transitions to glacial till. A masonry core wall extends the full height of the dam.
