## An extensive jet grout test program for a low permeability barrier

Naresh Gursaud, Jim Bruce & Mark Montgomery  
Geo-Foundations Contractors Inc., Acton, Ontario, Canada

### ABSTRACT

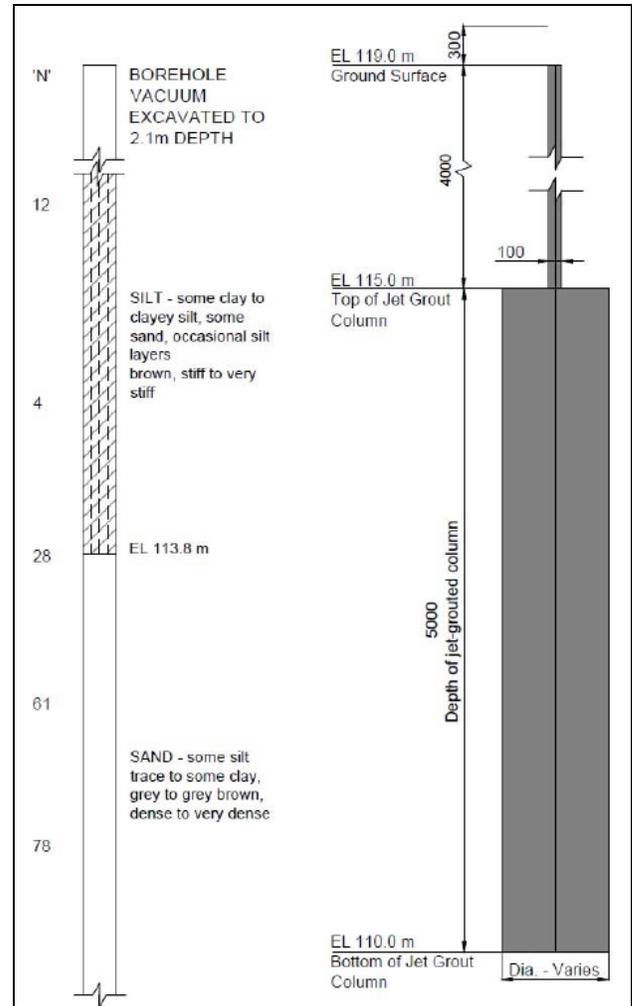
Figure 3. Subsurface profile and test column section

The subsurface material present within the project area comprises of fill of thickness ranging from 1 to 3 m, clayey silt to silty clay, sand to sand and silt and clayey silt to silty clay till (Fig. 3). Ground water level varies from 4 to 5 m below existing grade. The groundwater level at the site fluctuates as a result of seasonal variations in precipitation, runoff and temperature at the site.

Excavation depths for the depressed corridor will extend to 12 m and into the fill, clayey silt to silty clay, and sand to sand and silt deposits. The sand to sand and silt soils are water bearing and form an aquifer at the site. Approximately 550 lineal metres of the proposed excavation will be below the groundwater table.

The interlocking pipe pile was designed to penetrate below the groundwater level and extend to the underlying cohesive clayey silty to silty clay till to restrict the potential flow of water into the excavation. Sheet pile cut-off walls were also installed perpendicular to the main support walls to form cells where the main excavation penetrates below the baseline groundwater level.

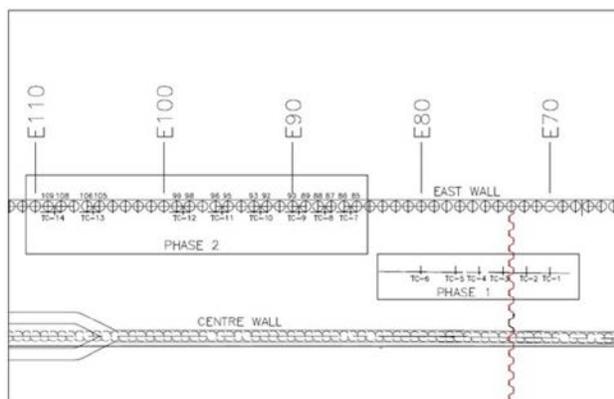
Figure 4. Layout of test columns

Jet grout test columns were installed in three phases, totaling fourteen test columns. All fourteen test columns were installed at the East Corridor between pipe piles EW70 to EW109. A layout of the test columns is shown in Figure 4. Phase 1 test columns were installed at the centre of the East Corridor between piles EW70 to EW80. Six columns were installed in Phase 1 to evaluate a wider range of lift rates (i.e. 0.2 to 0.6m per minute). Phase 2 test columns consisted of a set of eight test columns installed adjacent to the East Wall (west side). These columns were offset 0.5 m from the centre of the P-T interlock and installed between piles EW85 and EW109. Test columns were constructed from Elevation 119.0 m and jetted from Elevation 115.0 m to 110.0 m. The permeability testing methodology was modified for Phase 2 test columns. Phase 3 testing was performed on two additional production jet grouted columns.

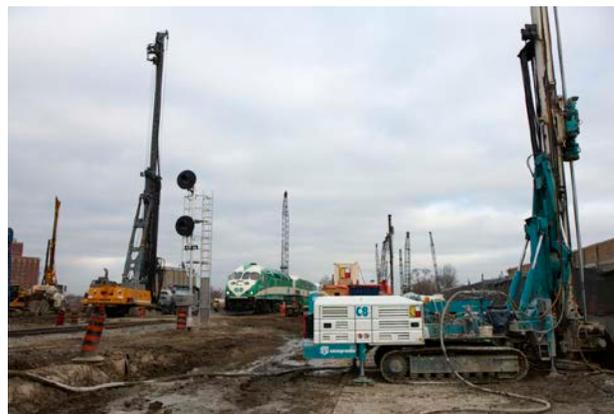
Figure 5. Site arrangement at test area

during Phase 1. Figure 5 shows the site arrangement at the test area.

A steel conductor pipe was installed coincident with the central axis of each column, after completion of jetting, in Phase 2 such that the pipe extended from surface to 6mbgs. The steel pipe was secured at surface by using steel hangers. These pipes were installed to function like an overburden casing to facilitate in situ permeability testing. No conductor pipes were installed during Phase 1 since the columns were exhumed prior to conducting the in situ permeability testing. PVC conductor pipes were installed prior to backfilling the exhumed Phase 1 test columns. The installation of the conductor casing was improved during Phase 2 based on lessons learned.

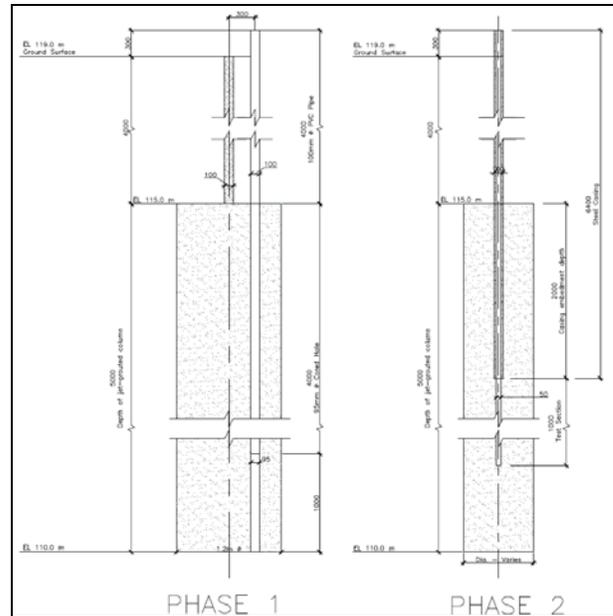
Figure 6. Test column arrangement for Phases 1 & 2

was done to verify the consistency of the jet grout column. Additionally, TC-12 was exhumed for visual inspection of the jet grout/P-T interlock interface. Both the video inspection and the exhumation provided valuable information and confirmed a uniform consistency without any indication of voids. The seal created at the P-T interlock was also confirmed to be watertight. Figure 6 shows the test arrangement for Phases 1 and 2.

Two of the test columns TC 1 and TC 4 were cored using a HQ coring assembly in an attempt to ensure that the post-installation drilling process did not damage the test column to an extent that would preclude in situ permeability testing. Coring of the test columns was performed six days after installation. The jet-grouted columns were cored from 4 to 8 mbgs (EL. 115.5 to 111.5), leaving the bottom 1 m of the column intact. A sleeve pipe was installed above test columns TC 1 and TC 4, after the diameter was verified by open cut-excavation. The sleeve pipes were offset from the centre of columns TC-1 and TC-4 by 0.3 m and 0.15 m respectively.

A 50mm diameter hole was drilled at the centre of the conductor pipe to a target depth of 7mbgs. This resulted in a 1m test section of the soil-grout mass for in situ permeability testing. The drilling of the 50mm diameter hole was done by using a bicone drill bit and rotary drilling technique. Water was used as the flushing medium to advance the hole to the target depth. Drilling of test holes was performed approximately one week after the columns were installed. Each test hole was flushed clean upon completion of drilling.

A borehole pressure transducer (Level Troll 500) was lowered to approximately 100mm off the test bottom of the drilled hole and the cable was secured to the riser pipe. The water level trend in the drilled hole was measured for half a day to confirm that static equilibrium condition has been reached. After confirming that static water level has been achieved, a slug test was conducted.

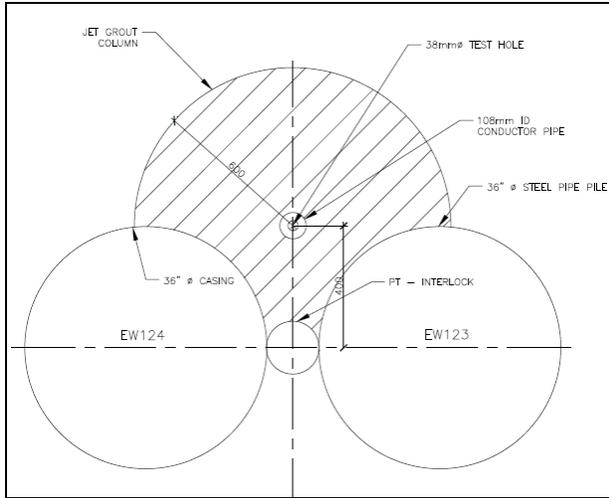
Figure 7. Layout of Phase 3 jet grout test column

After achieving static conditions, a slug test was performed and all test data was captured using the Level Troll downhole pressure transducer. The data obtained from the test were analyzed using Hvorslev's method. The layout and arrangement for Phase 3 testing is shown in Figures 7 & 8.

Proof testing was performed on two production jet grout columns. A steel conductor pipe was installed coincident with the central axis of the freshly installed column. This pipe was installed to function as an overburden casing to conduct the in situ permeability testing. Spoil samples were also taken for laboratory permeability testing.

A modified procedure was used for the development of the test hole by using a forming process rather than a drilling method. The modified method eliminated several uncertainties associated with the drilling of a test hole in the relatively weak soil-grout matrix. After setting the conductor pipe in place, an inner 28 mm diameter steel pipe with an end plug was installed to 1 m below the tip of the conductor pipe. The inner pipe was rotated periodically and remained in place for approximately 20 hours. The test hole was successfully developed with a significant amount of care and monitoring to establish a suitable time for the removal of the inner piper

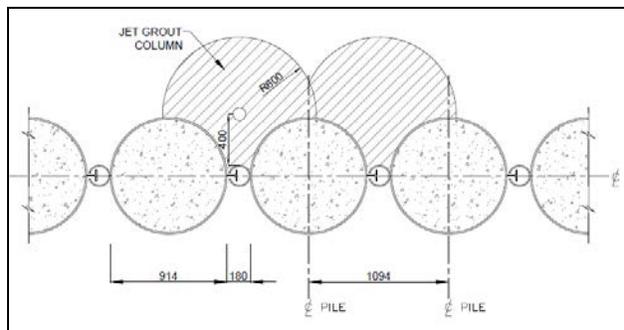
Figure 9. Typical layout of production jet grout columns

It was essential to gather as much information throughout the installation and testing of the jet grout columns. The testing approach was modified based on the conditions encountered at the site and lessons learned as the installation and testing progressed. A significant amount of data was acquired from the test program to establish conformance with the specified permeability. Figure 9 shows the typical layout of production jet grout columns.
