# DFI's 29th Annual Conference On Deep Foundations

## DESIGN AND CONSTRUCTION OF A MICROPILE WALL TO STABILIZE A RAILWAY EMBANKMENT

Jim Bruce, Geo-Foundations Contractors, Mario Ruel, CN Rail  
Nadir Ansari & Matthew Janes, Isherwood Associates

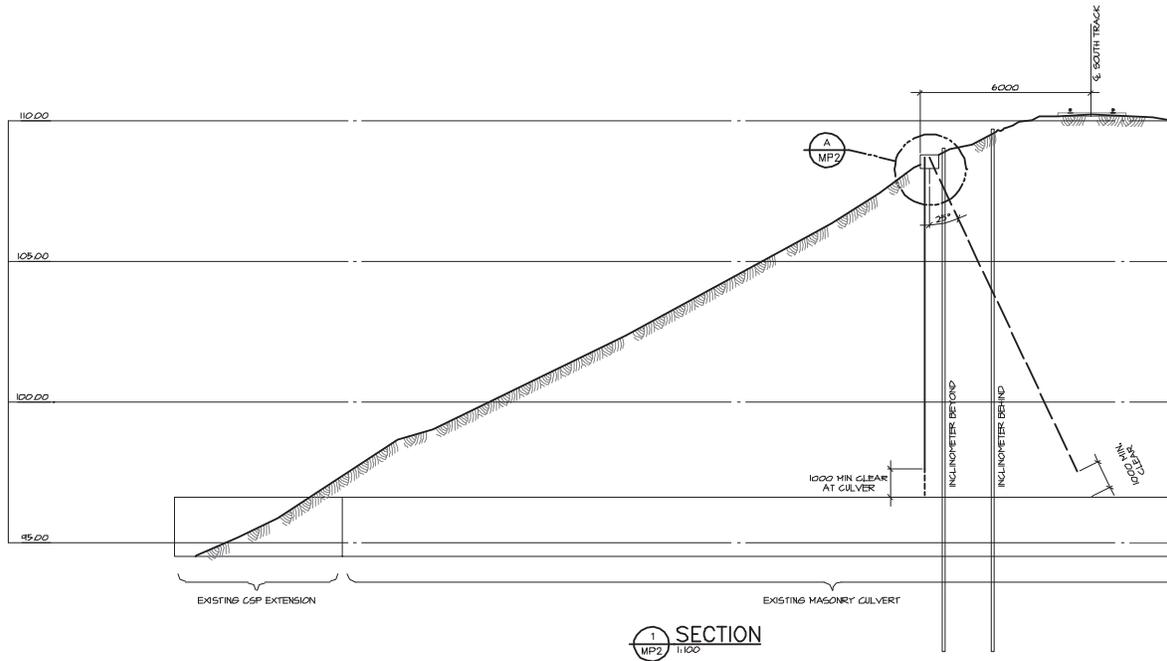
**Figure 1** Geometry as modeled in the analysis.

Figure 1 indicates the geometry as modeled in the analysis. Section 2, station 0+175.6 at the approximate mid point of the slide area was analysed. The geometry models the embankment looking East along the axis of the rail lines. The top of the embankment was assumed to be at elevation 110.0 m and the bottom of embankment on the South side at elevation 94.0 m for a total

embankment height of 16 m. The soil strata was assumed to be dewatered to the elevation of the ditch at 94 m. Figure 2 provides a representation of the FLAC grid with the micropiles in place. The FLAC grid is 100.0 m wide and 30.0 m high. The grid was not symmetrical about the centre line of the excavation, but follows the contour of section 2, slide 1. Micropiles are spaced at 0.5 m centres and assume a Titan 40/20 injection anchor within a 125 mm diameter grout column. The entire grid is modelled but

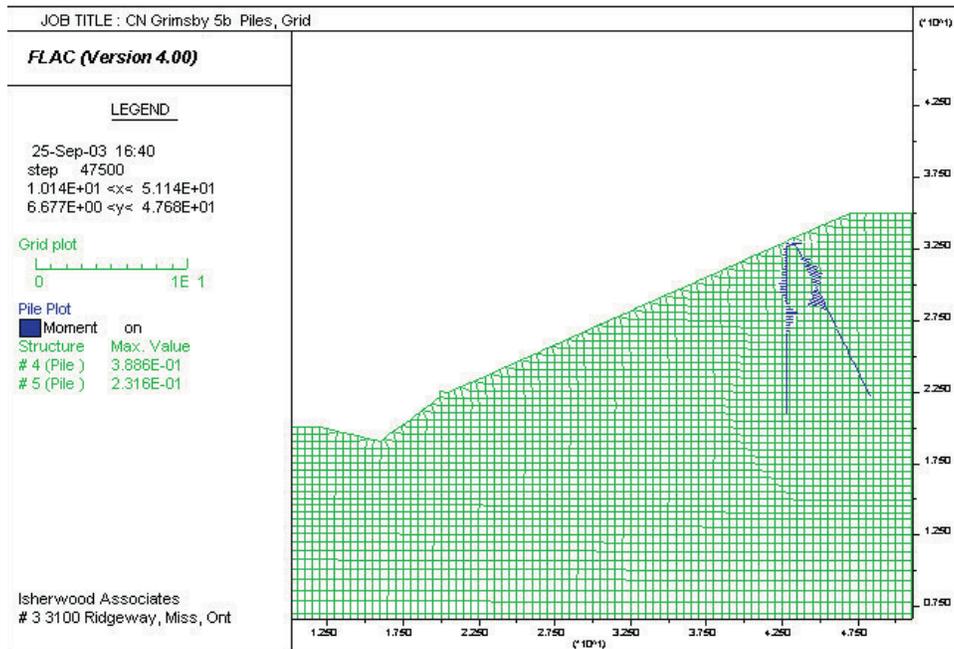
**Figure 2** FLAC grid with the micropiles in place

the figure indicates only the south embankment and non reticulated micropile wall structure for clarity. The micropile cap beam structure is modelled as a reinforced concrete beam with a thickness of 450 mm, width of 600 mm,

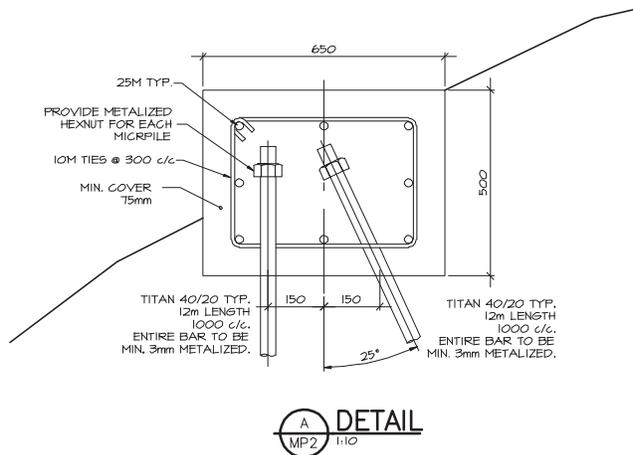
**Figure 3** Detail Micropile cap.

elastic modulus of  $4.5 \times 10^4$  MPa and a mass of  $2500 \text{ kg/m}^3$ . See figure 3 for a detail showing the pile cap geometry as constructed.

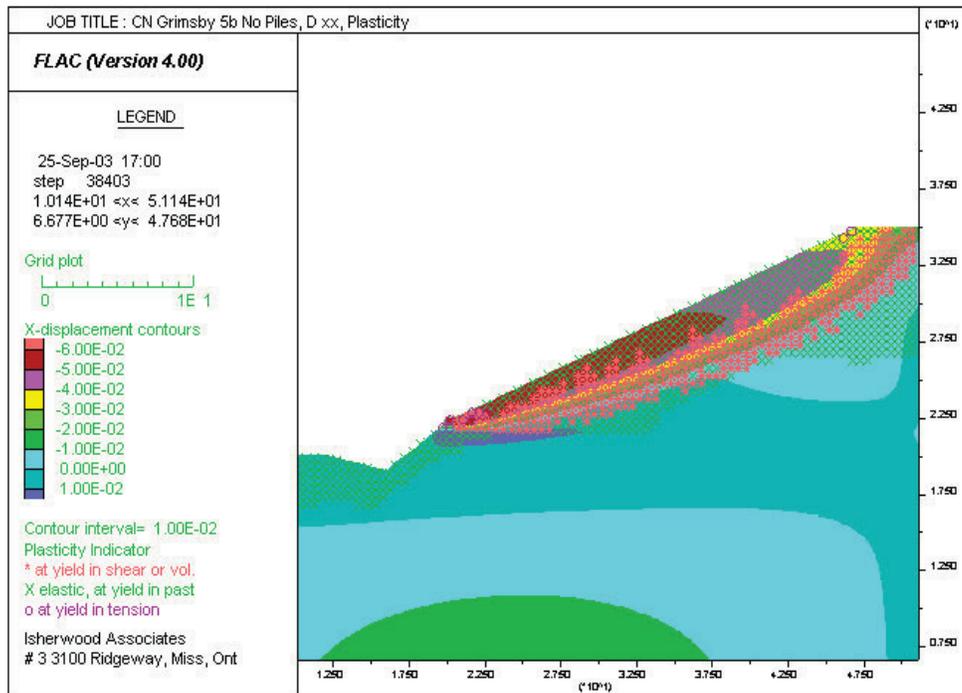
Figure 4. Typical failure profile with reduced soil  $\Phi$  properties.

about the same depth as the FLAC analysis and under similar soil conditions. However, the XSTABL analysis provides a family of failure curves (or near failure curves with a FOS of 1.0) whereas the FLAC analysis indicated what appeared to be a single shallow (4 to 6 m depth) seated failure surface with each run, see Figure 4.

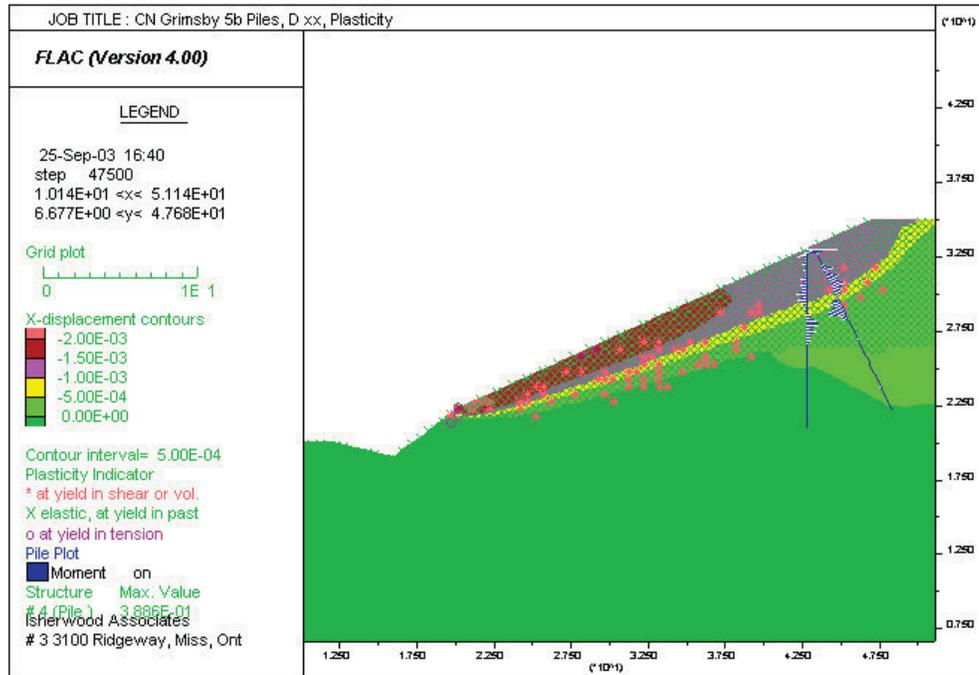
Figure 5. Embankment analysis with optimised micropiles and 3° reduction in  $\Phi$ .

A  $\Phi$  angle of 21.5° was investigated and showed significant deformation below the micropile wall, but a stable condition above. For the purpose of evaluating the improvement in slope stability a  $\Phi$  angle of 25.5° in the clayey silt is considered stable without micropiles and a  $\Phi$  angle of 22° with micropiles. A simplified but reliable measure of slope stability is to take:

The study indicates lateral deflection of the micropile wall structure occurs in the direction of the downward slope on the order of 1-2 mm for the critical case. The south rail tracks, which rest upon this elastically mobilized soil mass are also shifted laterally on the order of <1 mm towards the south embankment. The movement of the slope soils in the region of the micropile wall are on the order of 5 mm.

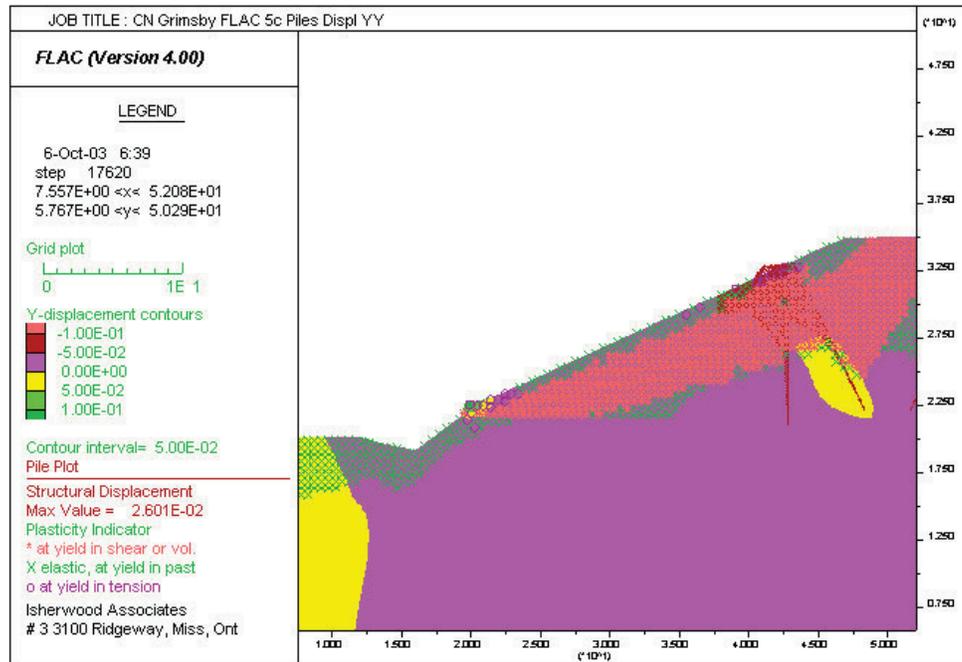
Figure 6. Embankment analysis with optimised micropiles and 4° reduction in  $\Phi$ .

condition was achieved. The relationship between the original and the 'new' post micropile wall embankment stability and failure soil properties were compared. The increase in slope stability was established by comparing the relationship between the Tan of the internal angle of friction of the original soil properties and the those of the 'new' post micropile wall soil properties at the critical condition. A combined reduction in Phi angle ( $\Phi$ ) of  $2^\circ$  in the silty sand ( $26^\circ$ ) and  $3^\circ$  in the lower silty clay fill ( $22^\circ$ ) was achieved while maintaining a stable micropiled embankment, see Figure 5. When the phi angle was reduced a further degree, to  $21^\circ$  in the lower silty clay fill the embankment began to exhibit global distress, Figure 6.

The failure case for the micropile wall, when the  $\Phi$  angle was reduced by 4° indicates extensive soil and pile movements downslope on the order of 100mm. Pile movements increase to 25 mm and micropile bending exceeds the capacity of the micropiles.

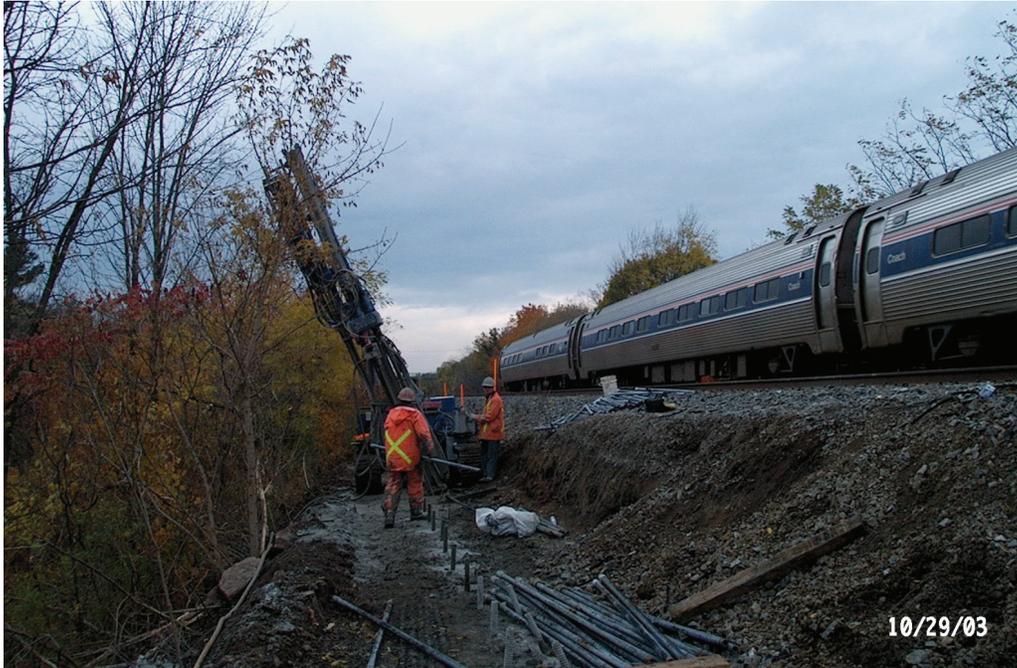
**Figure 7.** Installation of micropiles during track operation.

The contractor installed the micropiles using a Hütte HBr 605d rig placing Titan 40/20 injection anchors. A 115 mm soil bit was used with continuous grout flush and top hammer rotary percussion. This particular installation process was selected for the combination of enhanced geotechnical performance of the micropiles and the high attenuation of installation energy in the proven fragile embankment soils. The embankment was notched very slightly in the area of the micropile wall to accommodate

positioning of the rig and construction of the micropile cap. Figure 7 shows the micropile installation. Note the presence of passing rail cars in Figure 7 – rail service was not interrupted at any time

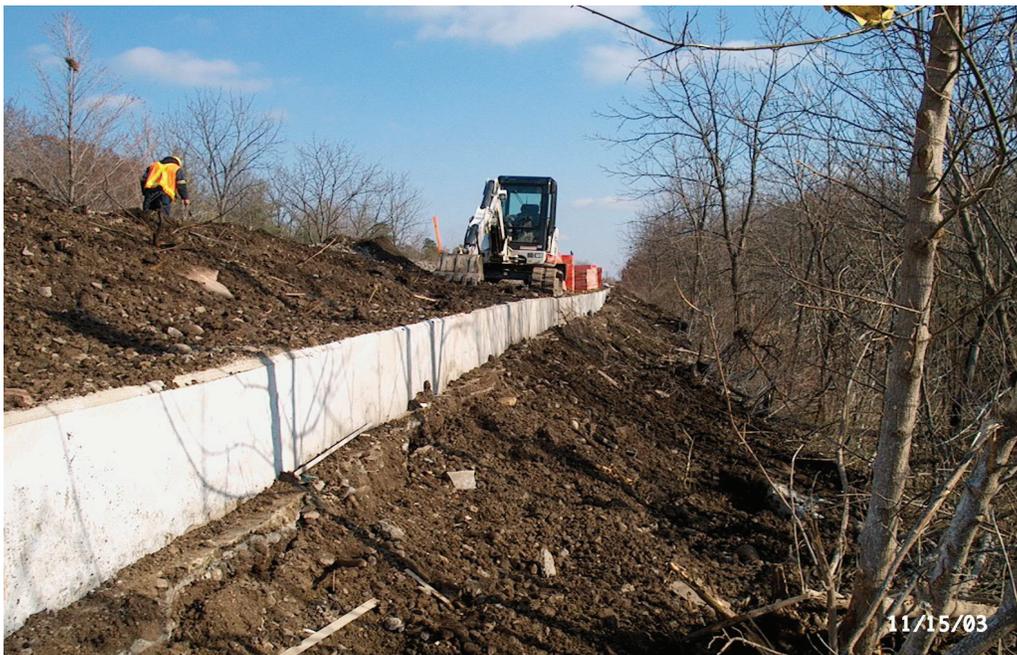
**Figure 8.** Embankment grading following pile cap installation.

due to micropile wall construction. Figure 8 shows the re-dressing of the embankment following the completion of the pile cap placement and stripping of forms.

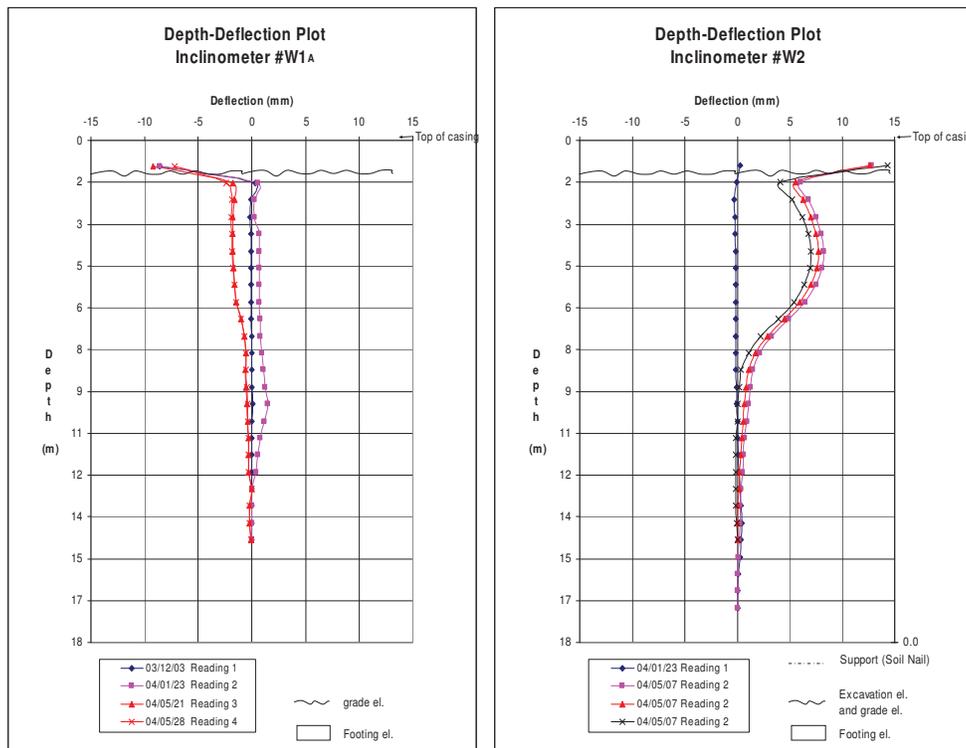
Figure 9 Up-slope inclinometer readings.

The results of the inclinometer readings are provided indicated in Figure 9.

It may be seen that the top of the inclinometer casings have been moved due to vandalism. In addition it appears that inclinometer 1 has not moved appreciably whereas inclinometer 2 indicates up to 7.5 mm of movement down-slope. This movement is probably due to continued movement of the shallow slide. The FLAC analysis indicated that soil movements of 7.5 to 10 mm would be required to fully mobilise the resistance of the micropile wall.

Inclinometers were placed approximately 1m up slope from the micropile wall and are to be monitoring over a three year period. The inclinometers are spaced approximately 10 m apart, on either side of the midpoint of the length of the 60 m wall. The initial readings were taken in December of 2003. The first set of follow up readings was taken in the spring of 2004. Due to vandalism of the inclinometer caps interruption of data acquisition was experienced. Follow up visits to repair the inclinometer top sides enabled additional readings to be taken.
