26th Street Emergency Repairs

Baltimore, Maryland

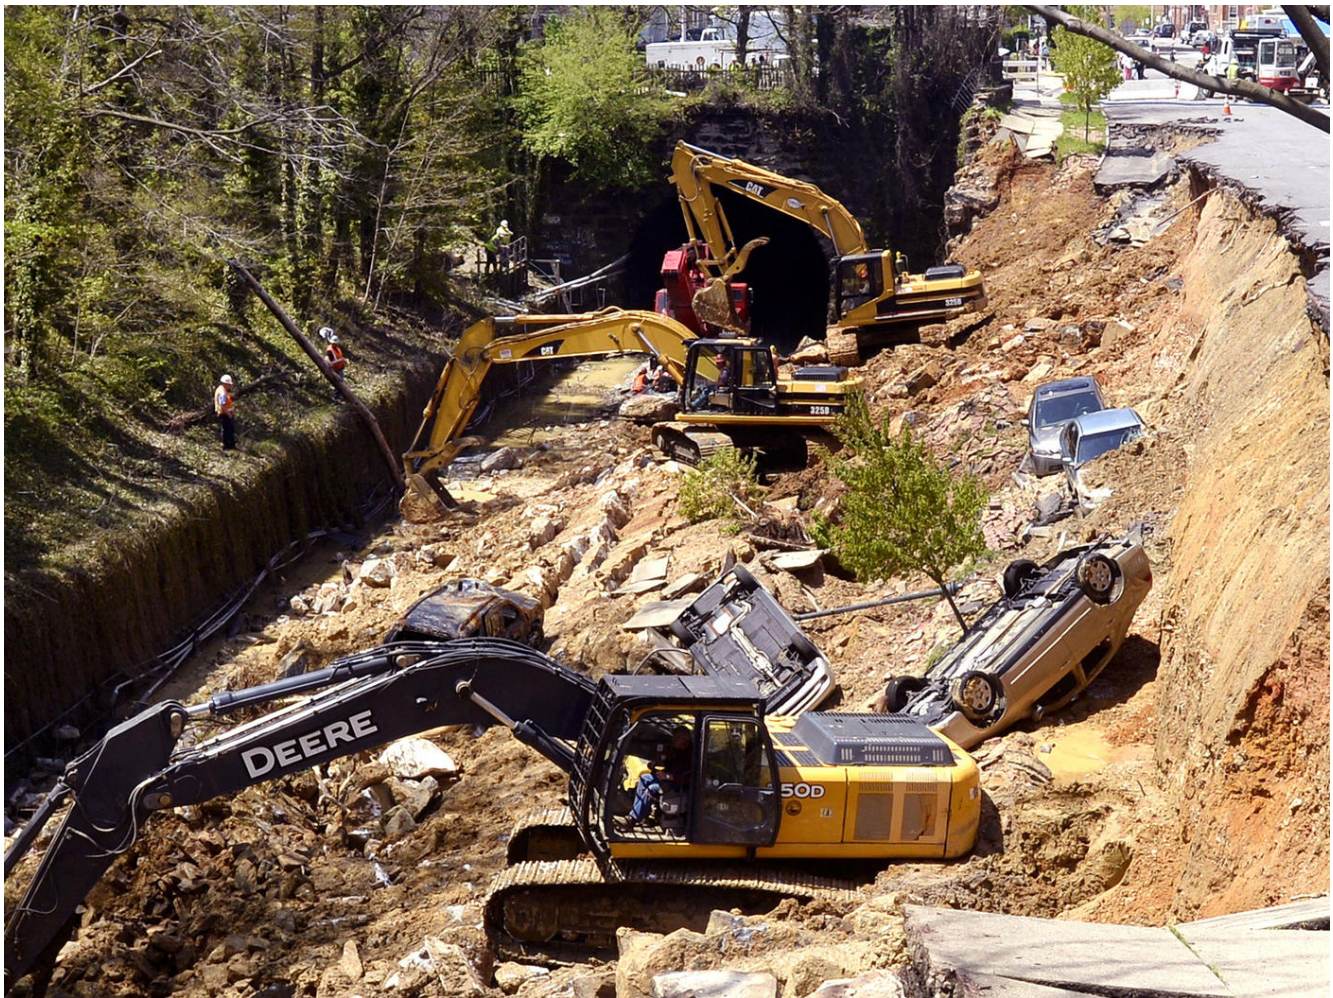
On April 30, 2014, a century-old stone masonry retaining wall failure occurred after heavy rains. One lane of East 26th Street, the sidewalk, 8 parked cars, light poles, trees, and tons of soil slid approximately 40 feet covering the adjacent train tracks below with debris. The collapse was caught in a dramatic video and broadcast nationally.

The catastrophic collapse of the retaining wall posed an immediate threat to the adjacent street and homes. With limited knowledge of the existing subsurface conditions and geometry of the retaining wall, the project team needed to quickly design and safely install an earth retention system.

Keller constructed a temporary, anchored soldier pile and lagging earth retention system to stabilize the street and homes. The soldier pile wall was located near the top of the failure plane of the soils, allowing for removal of the debris and construction of a permanent concrete retaining wall.
