## 5th Street improvement

Goshen, Indiana

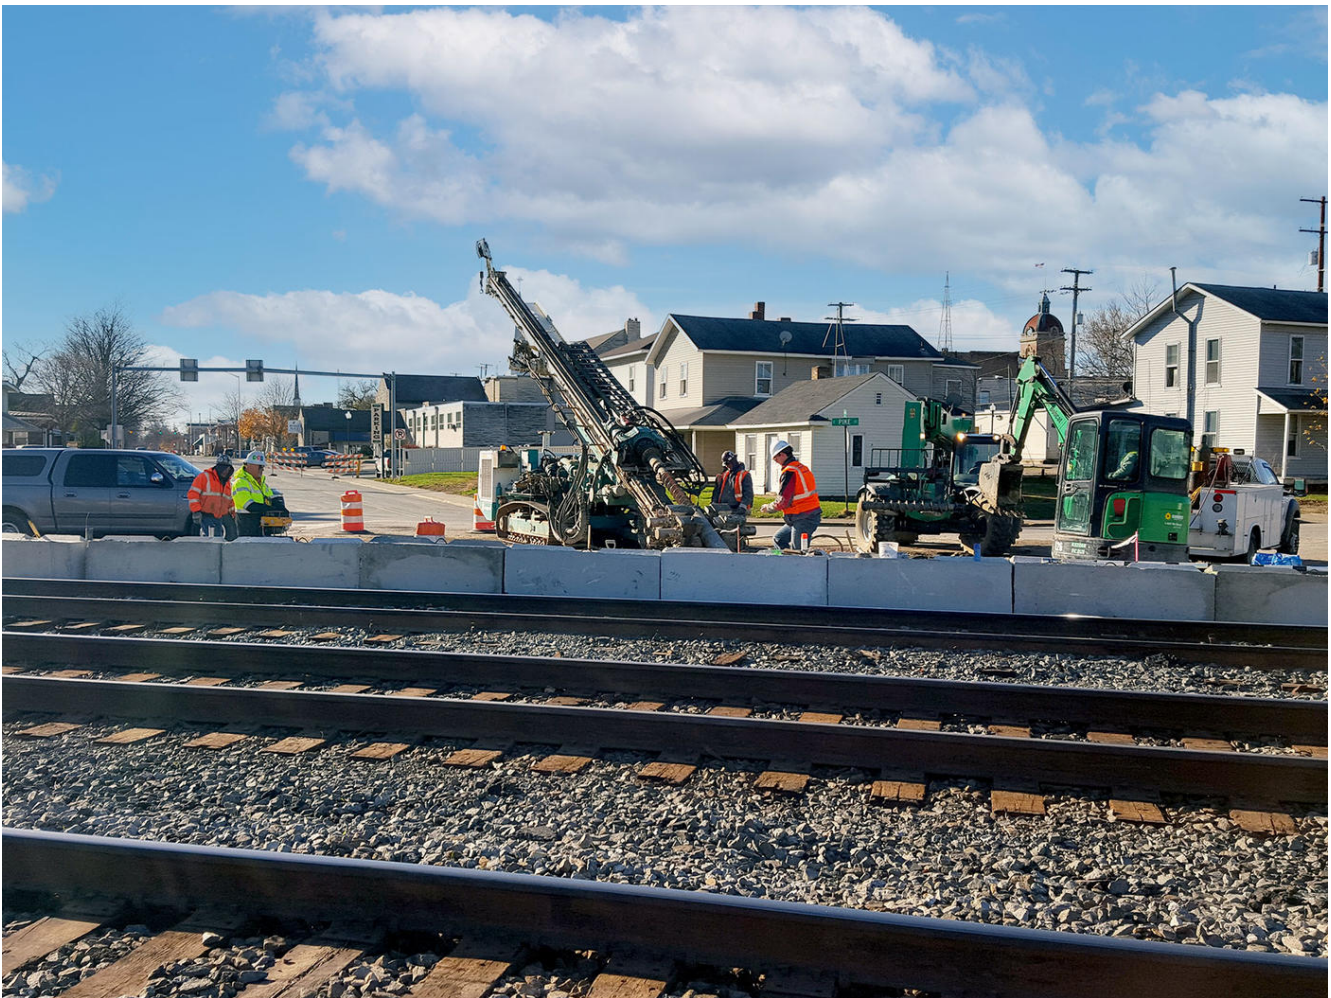
Geotechnical projects near active railroad tracks are challenging for the owner and the geotechnical contractor. Heightened safety awareness and minimal impact to rail traffic during the work are critical to a successful result.
