BNSF Bridge Sherman

Sherman, Texas

Critical relevering work needed to be done on the BNSF Bridge Sherman to ensure the safety of passing trains and passengers. Work was completed with minimal disruption to the train schedule.

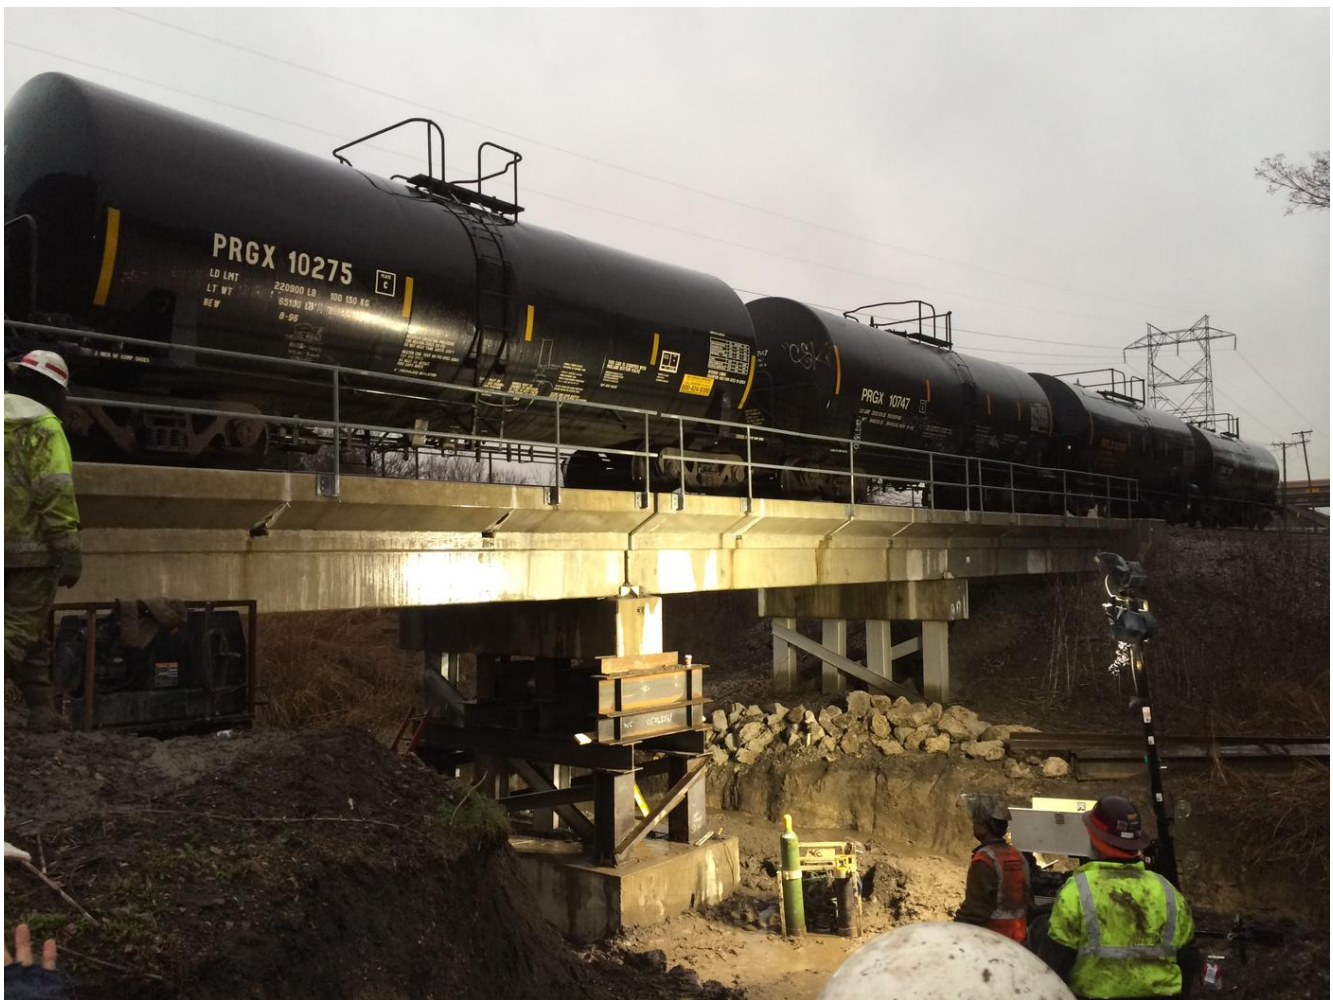
The existing bridge bent had experienced excessive settlement due to the failure of the existing bridge piers. The movement was observed as each train passed the bent. The pier movement resulted in a slow order of forty-five miles per hour.

Micropiles were installed to permanently support the existing bridge bent. A concrete pile cap was installed to connect the existing steel columns to the newly installed micropiles. A temporary steel lifting frame was built on top of the existing micropile concrete cap. The steel frame was pre-loaded hydraulically and the existing columns were cut loose. A hydraulic jack was utilized to lift the existing bridge bent to the construction elevation and the steel columns were repaired.
