## Osito Canyon Landslide Stabilization

Angeles National Forest, California

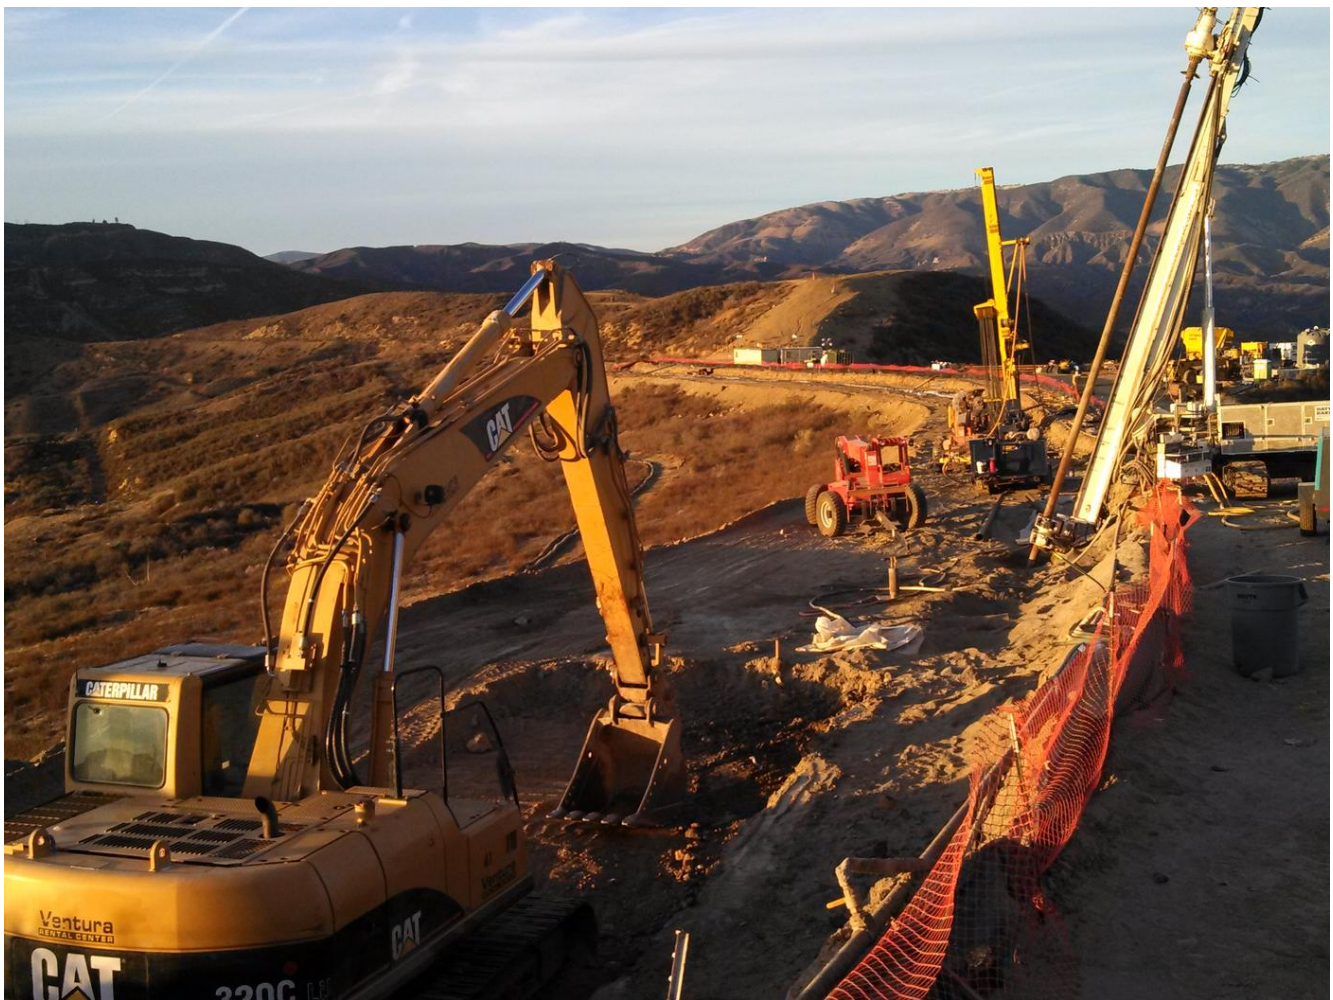
Slide events are common in Osito Canyon in the Angeles National Forest. During heavy rains in 2005, an approximately 900 ft long landslide occurred along the historic Old Ridge Route overlooking the canyon.

Several retaining structure options were initially recommended by the owner's engineer, including a tangent pile wall, a reticulated micropile wall (RMW), a soldier pile wall, and a soil nail wall. Keller was awarded the project after demonstrating its history of successful slide repair for previous national forest system slides where its Micropile Slide Stabilization system (MS3) was used. This approach was accepted by the owner and the National Forest Service. An MS3 wall would also require less truck traffic through the environmentally sensitive area and installation could be accomplished with smaller equipment. The 945-ft-long MS3 system consisted of tightly spaced battered micropiles installed through sleeved holes in a heavily reinforced 3-ft by 4-ft concrete grade beam. Evenly spaced 75-ft-long, 7-strand tieback anchors were installed through the grade beam for additional lateral restraint. Over 28,000 LF of reticulated micropiles and 7,500 tieback anchors were required to complete the retaining structure which was completed within schedule and on budget.
