## Sunset Road Bridge

Tucson, Arizona

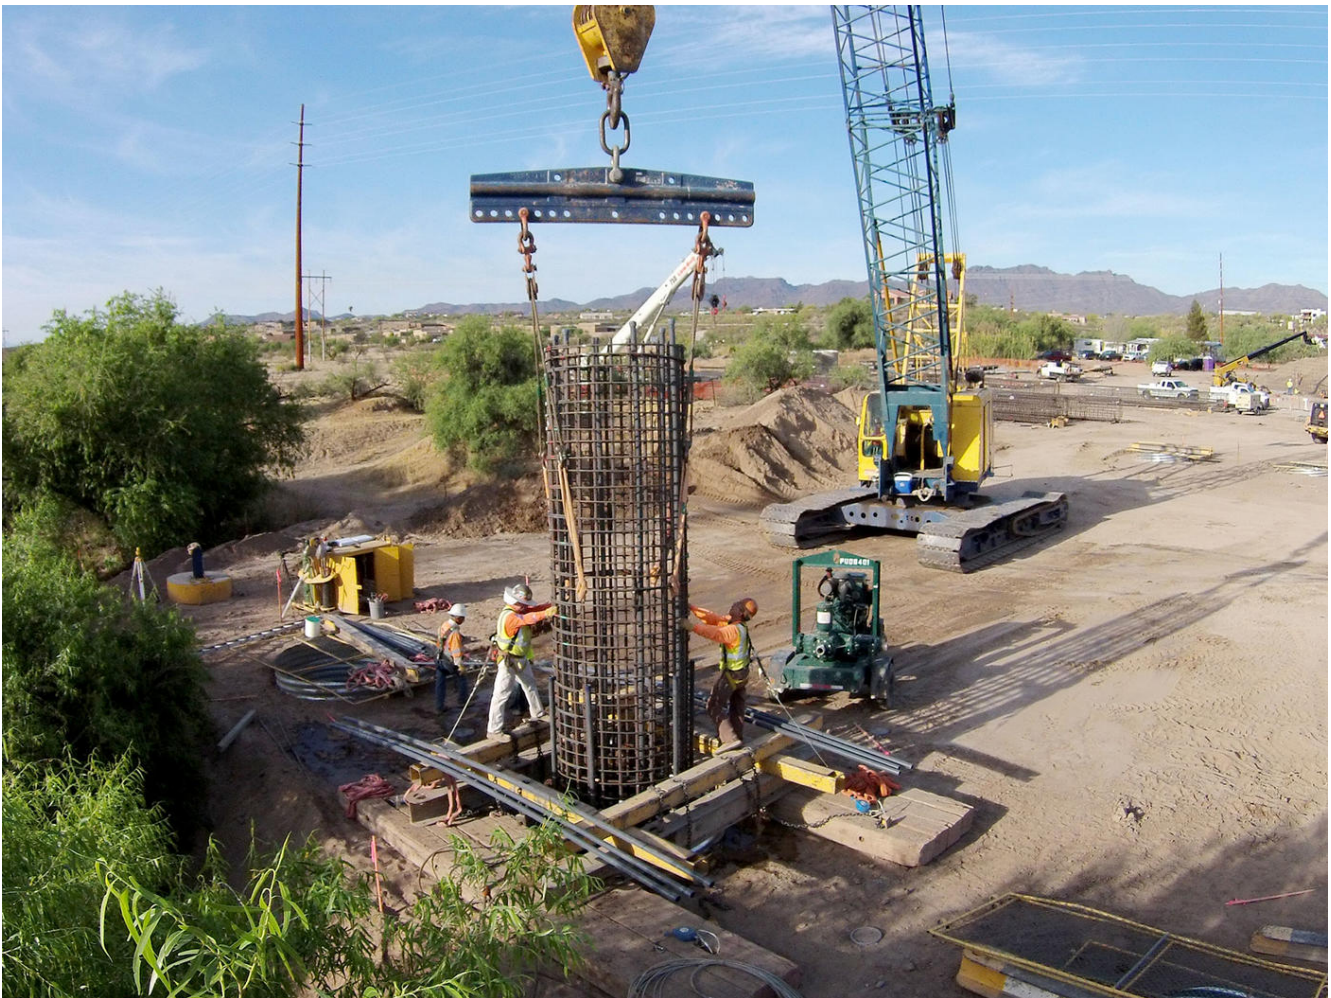
Keller installed all twenty-one drilled shafts under very challenging slurry drilling techniques without any shaft remediation or repairs required.

Environmentally protected lands along the Santa Cruz River limited the work area. There were two pier lines affected by overhead electric lines and one was able to be de-energized, but one pier line was not. Keller had to drill 138 feet and set the 139-foot long reinforcing cage in sections due to the live overhead power 83 feet above working grade.

Keller installed six drilled shafts with a 96-inch diameter ranging from 117 to 141 feet in depth and fifteen drilled shafts with a 72-inch diameter ranging from 138 to 144 feet in depth. All shafts were excavated and supported using polymer slurry. The reinforcing cages were fabricated in three pieces and spliced over the shaft where space was limited by overhead power lines. Keller also spliced integrity testing tubes, attached to the cages, for drilled shaft integrity testing. Two drill rigs were used to reach the shaft depth and diameters needed and fit under the limited overhead clearance to existing power lines.
