Jack Unit II STG Foundation

Bridgeport, Texas

Keller successfully mitigated the ongoing settlement of the foundation slab of a critical generator unit during peak summer demand without interrupting normal facility operations.

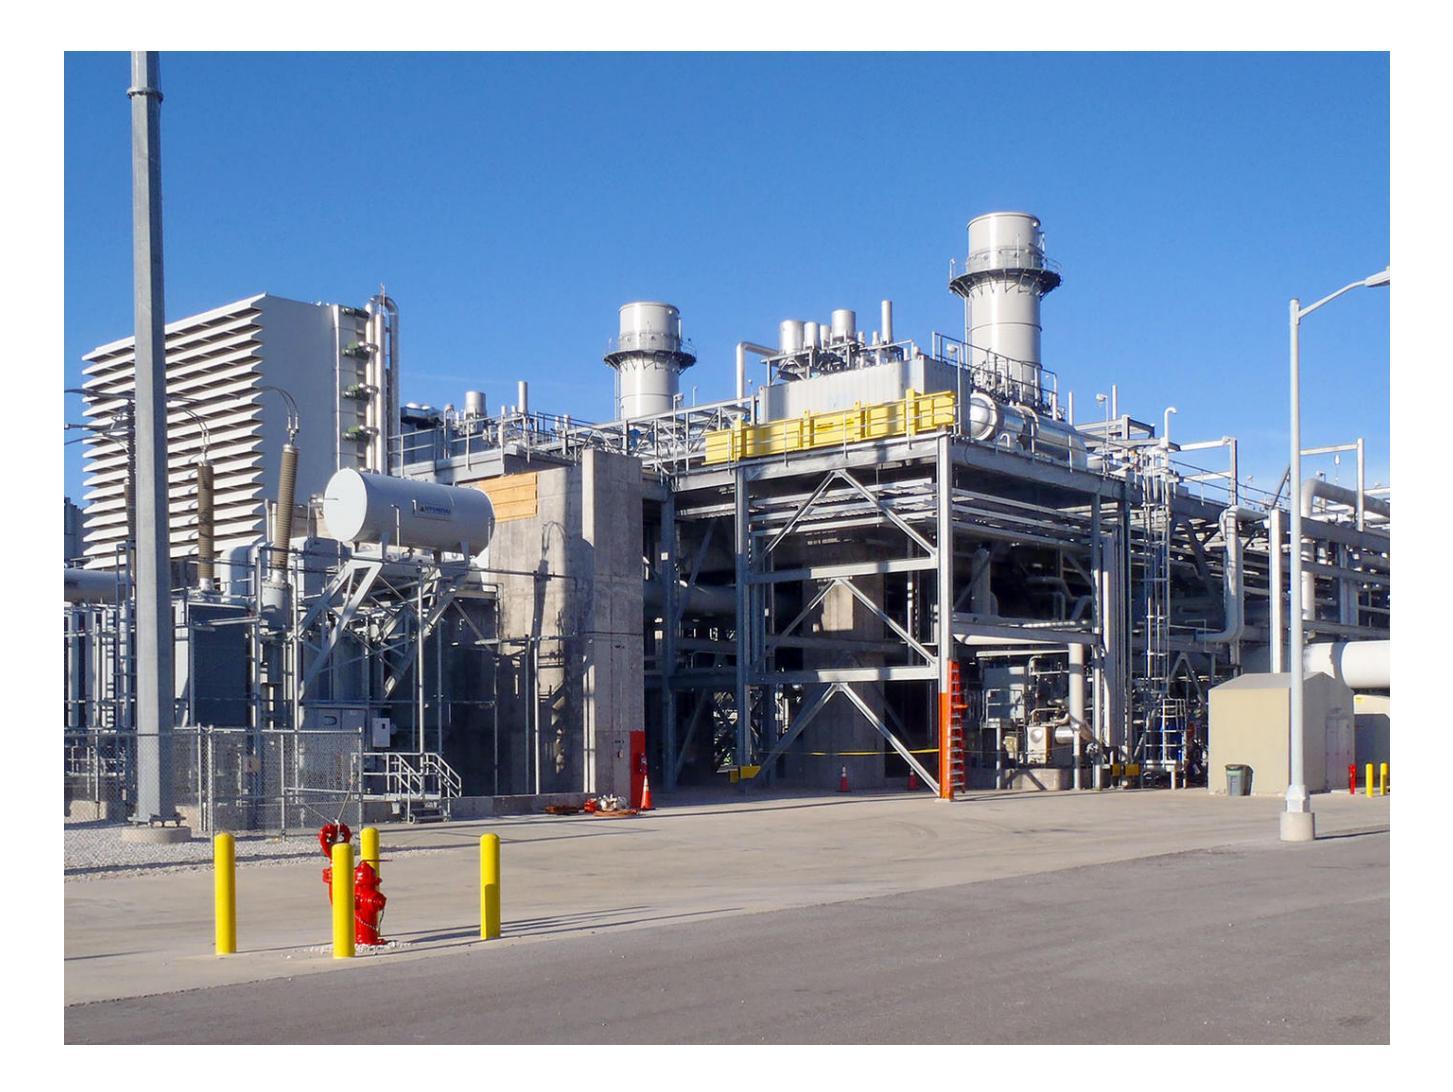
Over time, the foundation slab supporting a steam turbine generator (STG) had settled differentially and undergone twisting to the point where the STG was reaching the limits of tolerable operating conditions. The settlement was attributed to variably thick low plasticity clay foundation soils. A method of permanently mitigating the ongoing settlement, correcting the tilt, and lifting the foundation slab was required.

The operation of the STG was nearing a critical state due to the rate of settlement, which was causing stresses and unwanted vibrations within the structure. However, the unit could not be shut down for repair during peak summer demand, limiting the available rehabilitation options.

Keller developed a horizontal soil fracture grouting program accomplished from a secant pile-supported access shaft that would improve the soils and relevel the slab while meeting the owner's need for continuity of STG service. Following initial pre-conditioning of the ground, fracture grouting was accomplished through three levels of sleeve port pipes. Extensive instrumentation and real-time monitoring during grouting allowed precisely controlled lifting and releveling of the slab.
