Calgary Zoo

Calgary, Alberta, Canada

The project

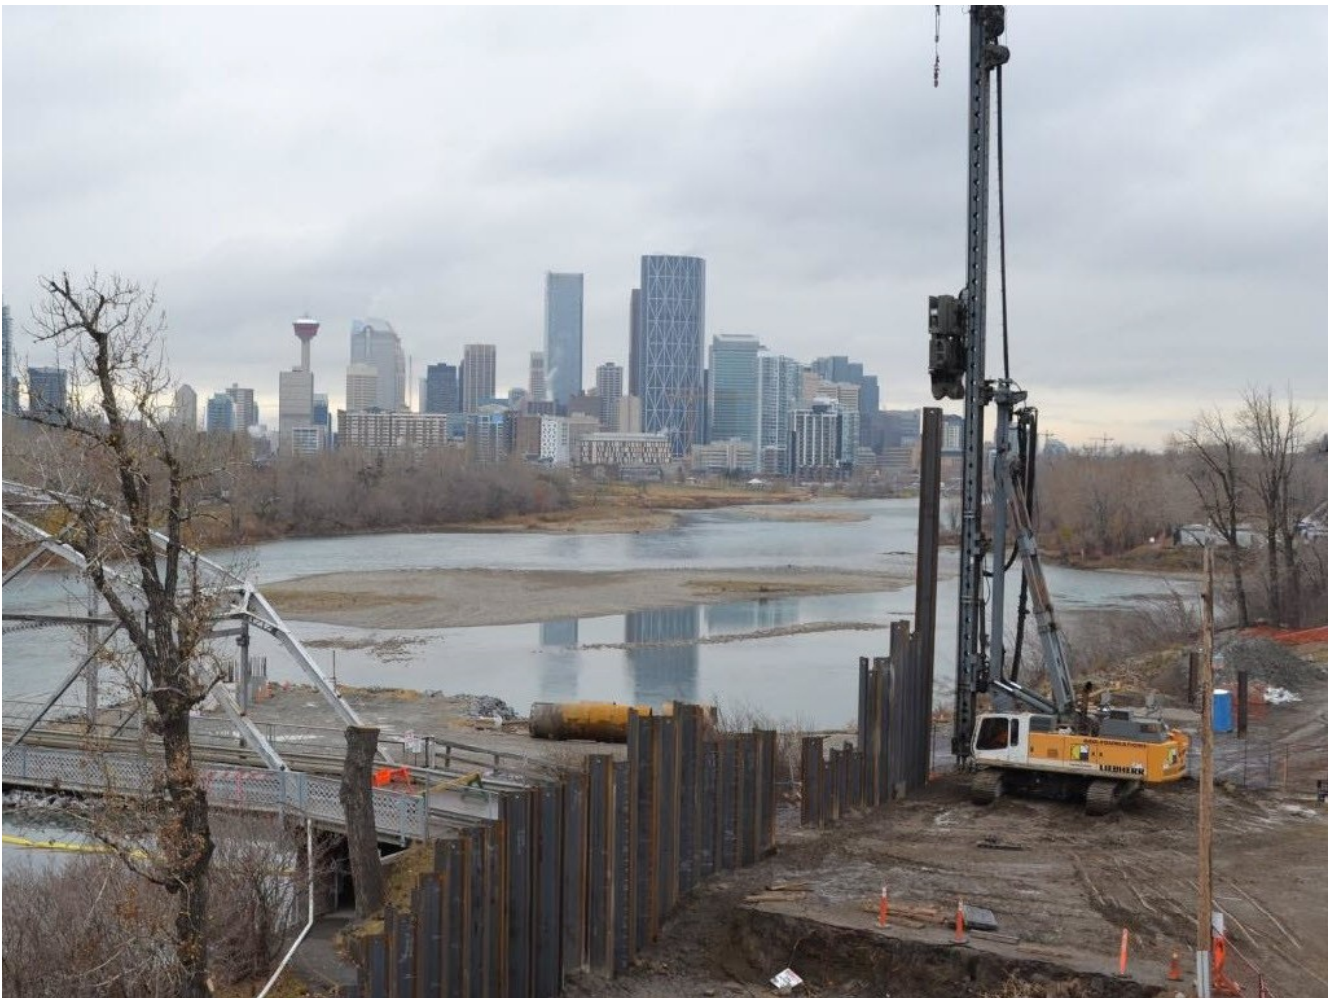
Keller worked under an aggressive schedule, resulting in a 50% reduction in time needed for the sheet piling installation.

A detailed execution plan was created and followed to address the logistics on the job site. Keller implemented a test program prior to being awarded the project to ensure quality and production targets could be achieved. We provided earth retention by installing 1,500 sheet piles to construct an above-grade flood wall with a below-ground cutoff wall around the perimeter of the zoo.
