Douglasdale McKenzie Slope Stabilization

Calgary, Alberta, Canada

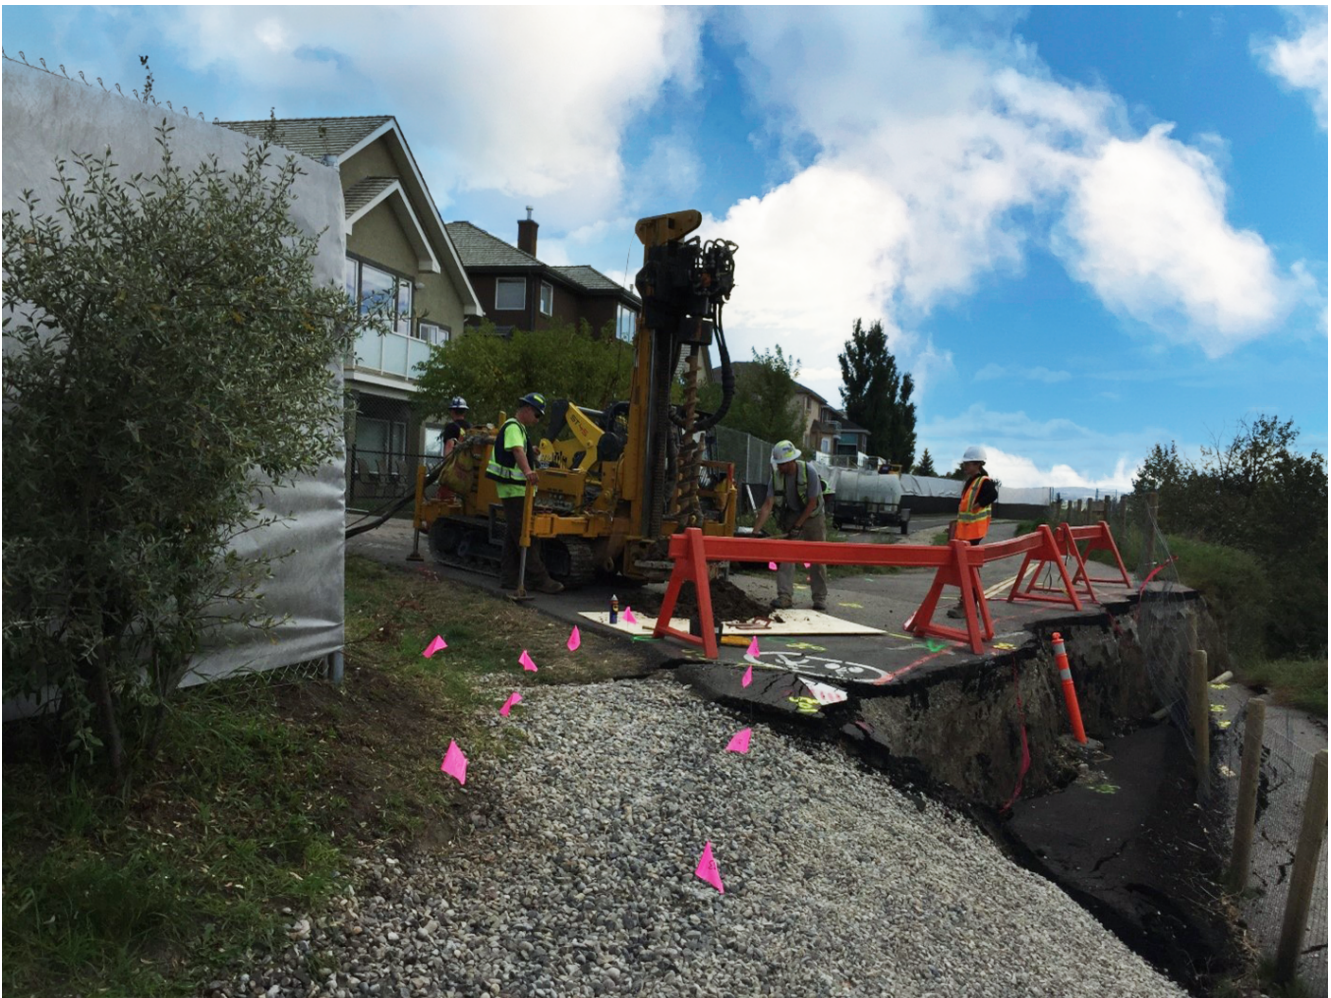
A steep embankment separates the Douglasdale and McKenzie Lake communities, overlooking the Bow River. At the top of the embankment, the City of Calgary maintains a regional pathway.

The landslide and additional material were excavated to a depth of 7.5 ft (2.3 m) to stop further movement at the crest of the slope, and Keller installed 90 cantilevered soldier piles and lagging to support the excavation.

Within the excavated area, Keller installed 354 micropiles to a depth of 49 ft (15 m) by-passing the weak soils to extend beyond the slip plane. Given the instability of the working area, Keller sequenced pile installation so crews would be working on the stabilized ground to install the next group of piles. To provide noise control, drill rig power packs were insulated. A propane generator was used to minimize air pollution and reduce diesel exhaust emissions.
