## Lake Manatee Dam

Manatee County, Florida

### The project

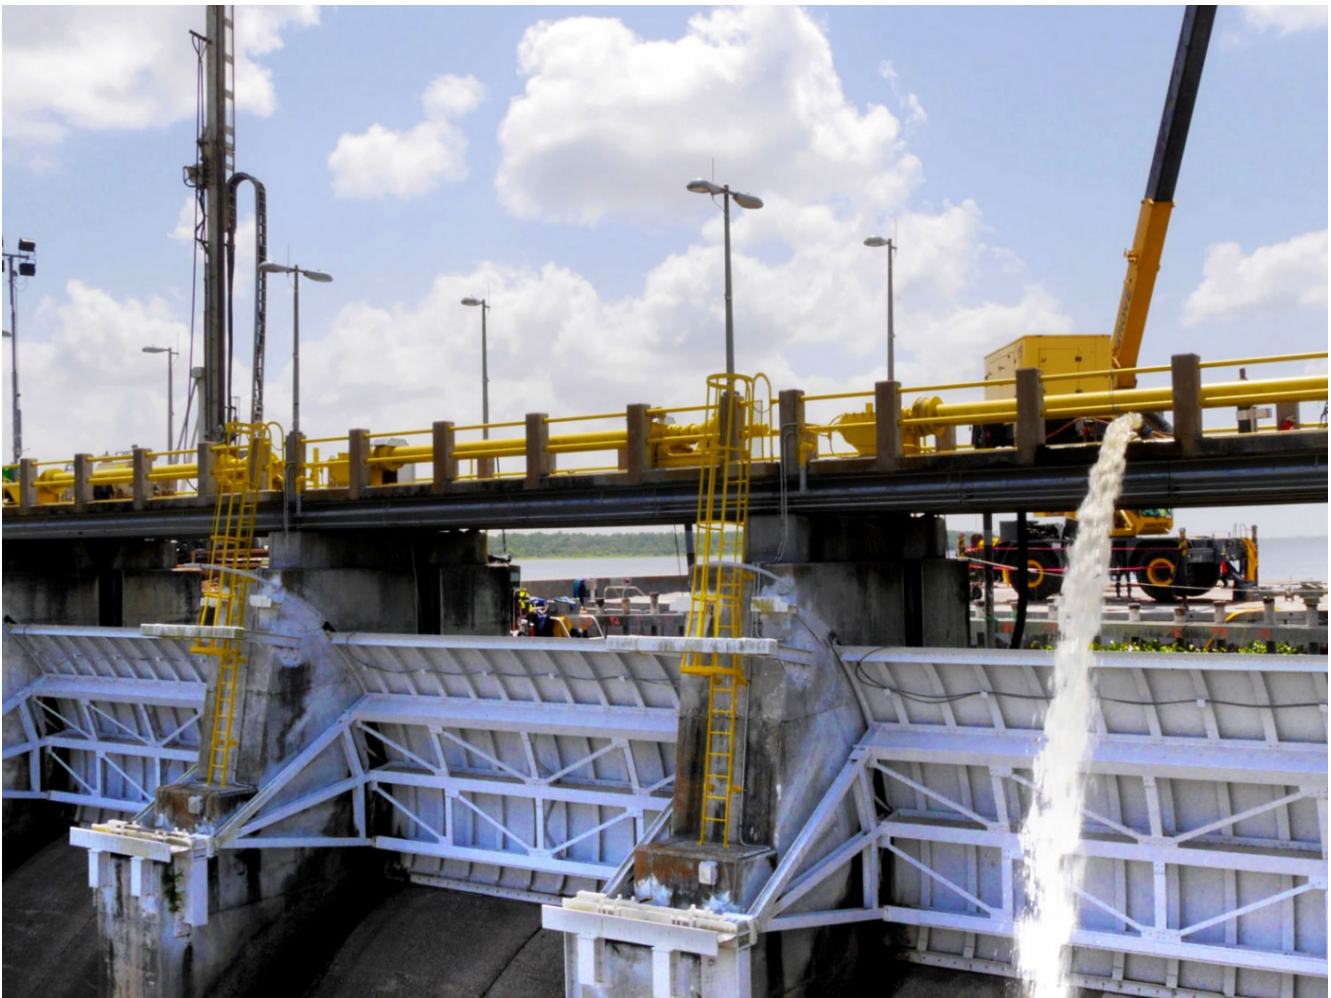
Keller accelerated construction to complete treatment of critical sections before the impending hurricane season with potentially catastrophic high-water loading.

From barges placed in the stilling basin, Keller cored small diameter holes through the spillway and constructed the underlying wall with overlapping 4-foot-diameter jet grout columns. A soil mix wall was efficiently constructed with the TRD method. The TRD process minimized risk to the dam since the thick, constructed in place, soil mix material would fill or choke off any erosion channels encountered.
