St. Vrain Mill

Mora, New Mexico

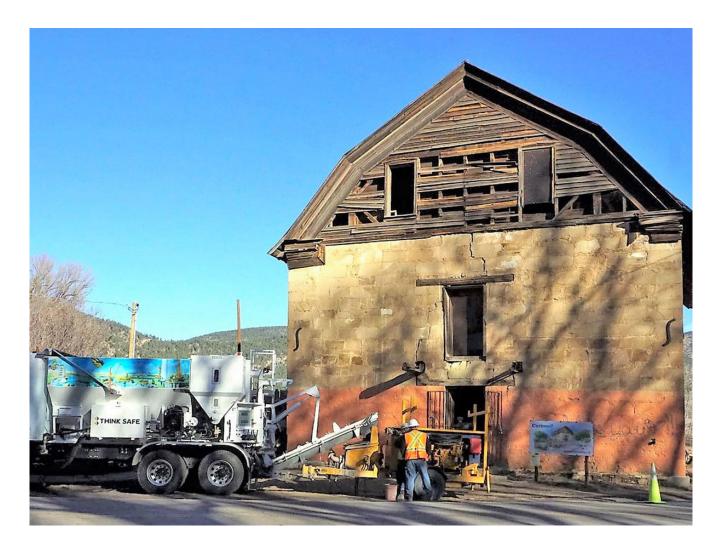
Keller conducted the structural and geotechnical remediation program using limited access equipment with no major distress to the historic property and its structures.

Keller performed permeation grouting to stabilize rubble foundation materials and the immediate soil to within four feet of the surface. Afterward, compaction grouting was conducted to increase the density of existing soils to 20 feet below grade. Specialty drilling equipment was used to safely install grouting locations near the canal that once powered the mill.
